NBS 3

# Brejos Community Garden

Project indicative: C3.0

Project type: complex intervention/measures and local regulation proposal

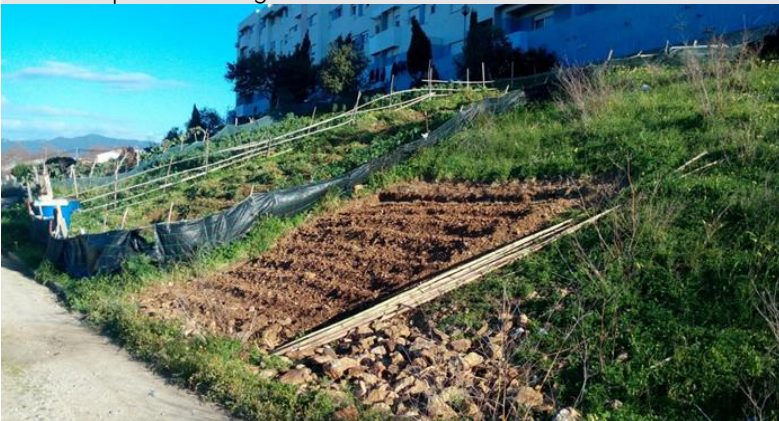
Before – spontaneous garden. Source Cascais Ambiente

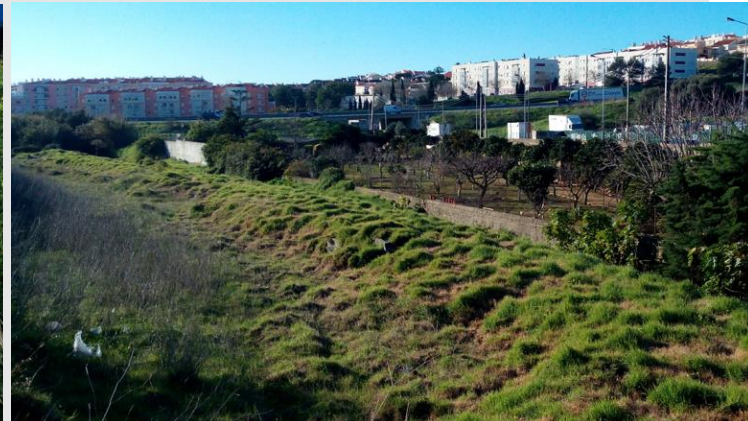
Before – abandoned land. Source Cascais Ambiente

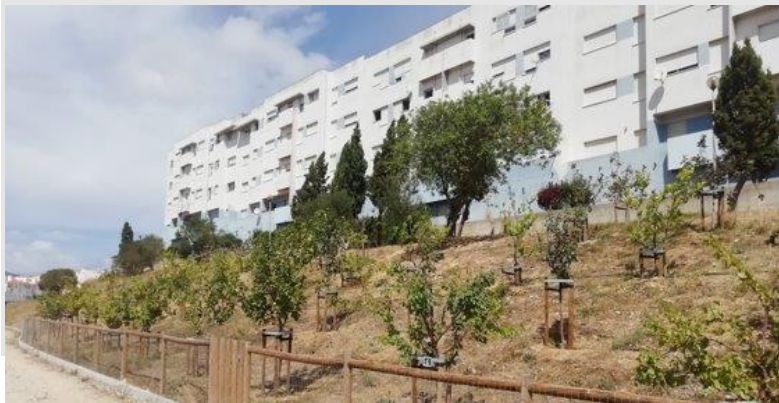
After – Urban orchard. Source Cascais Ambiente

Spontaneous gardens were transformed into a community orchard comprising four rows of fruit trees: apricot, pear, lemon, and apple trees, all enclosed by a fence akin to that of the vegetable garden. The trees were planted on the slope, in slight terraces to facilitate their maintenance.

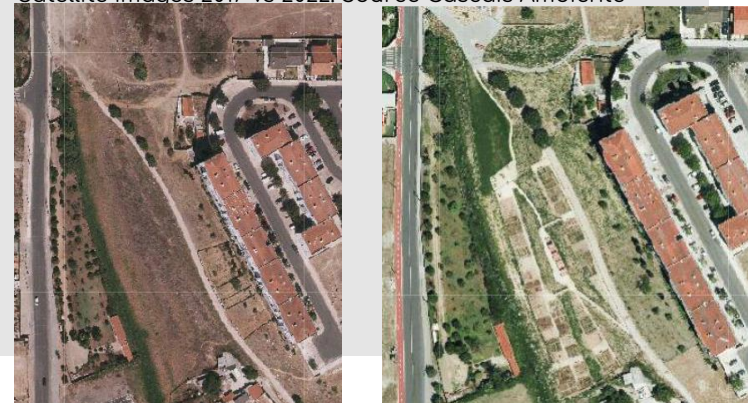
Satellite images 2017 vs 2022. Source Cascais Ambiente

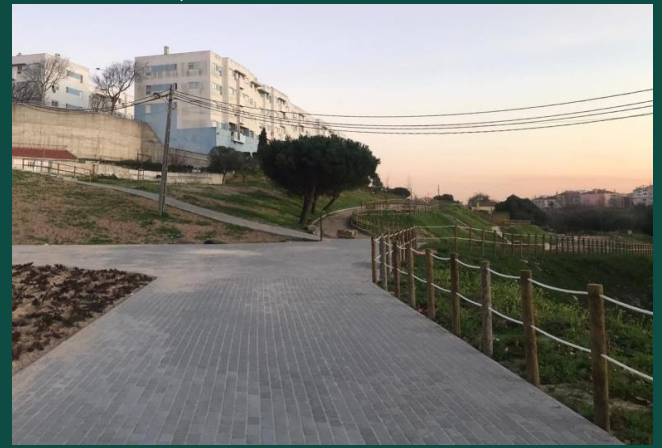
After – February 2022

The vegetable garden was developed across three existing levels, carefully designed to harmonize with the original terrain. This layout provides convenient access to cultivation areas on platforms and ensures stabilization of the slopes in-between. The garden's structure comprises 37 plots, each measuring 30 m<sup>2</sup>. A system for internal slope drainage was implemented, directing the runoff into the stream. At the central platform, tool shelters were set up for collective use among horticulturists, accompanied by wooden benches for relaxation. Wood was chosen as the primary material for path kerbs and plot dividers. A wooden structure covered with mesh netting forms the garden's fence.

Within the garden, the slopes were adorned with a meadow created through hydroseeding with a blend of pollinator-friendly herbs, ensuring both stabilization and biodiversity enhancement. Aromatic plants were thoughtfully incorporated into the area's landscaping.

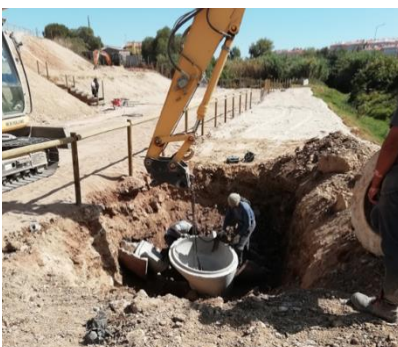
Ensuring access to rainwater pipes. Source: Coscais Ambiente

In the building process, the project had to be changed to ensure access to the rainwater pipes identified during excavations. During this process, several residents approached us expressing concerns about the lack of green space for recreation and leisure in the neighbourhood, which was initially requested during co-participation activities. As a result of this request, the project was altered, leading to a reduction of 3 cultivation plots and the creation of a new leisure green space adjacent to the garden

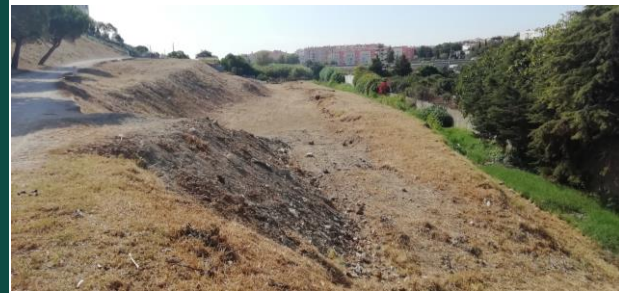
Sloped terrain. Source: Cascais Ambiente

- The design process was challenging due to the level differences and slopes.
- Landscaping is still required in the surrounding area.
- Public land was not available for the project.
- Acquiring additional land to execute the full project with a bridge connecting the riverbanks posed difficulties.
- Illegal occupation of public land occurred in two areas. One of them resulted in the project being divided into two phases. The initial design envisioned a walkway alongside the garden, reaching the bridge, but the illegal building was in the way. Currently, authorities are in the process of removing the building.

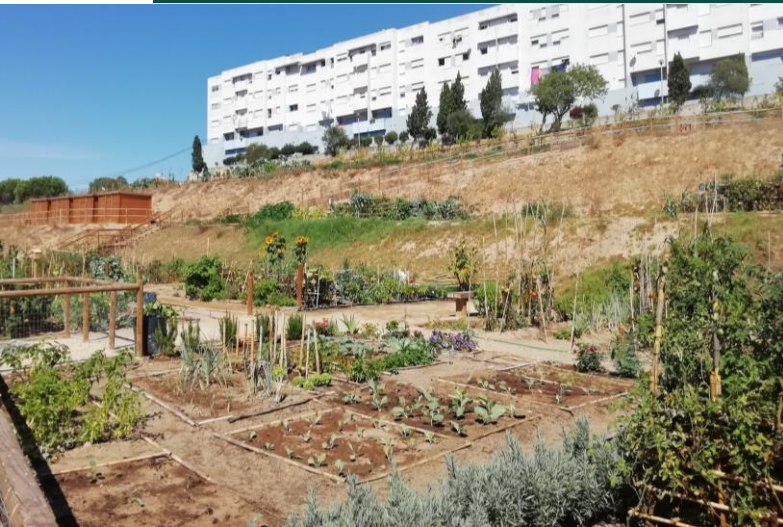
Illegal land occupation. Source: Cascais Ambiente
